DEPARTMENT OF TRANSPORTATION**DIVISION OF ENGINEERING SERVICES**

Contract #: 04-0120F4Cty: SF/ALA Rte: 80 PM: 13.2/13.9File #: 69.28**WELDING INSPECTION REPORT****Resident Engineer:**Siegenthaler, Peter**Address:** 333 Burma Road**City:** Oakland, CA 94607**Report No:** WIR-017474**Date Inspected:** 19-Oct-2010**Project Name:** SAS Superstructure**OSM Arrival Time:** 700**Prime Contractor:** American Bridge/Fluor Enterprises, a JV**OSM Departure Time:** 1900**Contractor:** Zhenhua Port Machinery Company, Ltd (ZPMC), Changxing Island **Location:** Shanghai, China**CWI Name:** Li Yang**CWI Present:** Yes No**Inspected CWI report:** Yes No N/A**Rod Oven in Use:** Yes No N/A**Electrode to specification:** Yes No N/A**Weld Procedures Followed:** Yes No N/A**Qualified Welders:** Yes No N/A**Verified Joint Fit-up:** Yes No N/A**Approved Drawings:** Yes No N/A**Approved WPS:** Yes No N/A**Delayed / Cancelled:** Yes No N/A**Bridge No:** 34-0006**Component:** OBG Segments**Summary of Items Observed:**

WELDING INSPECTION REPORT

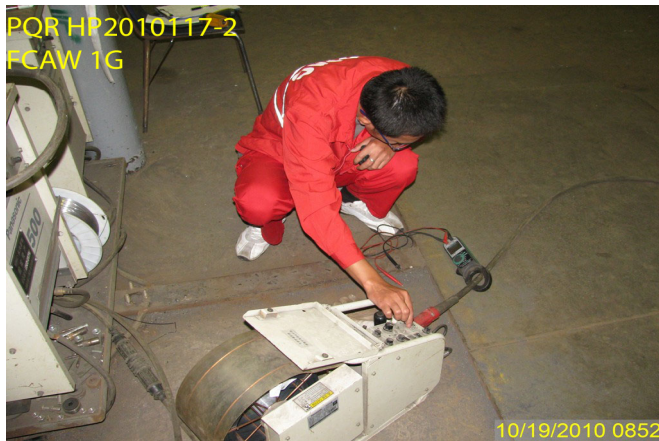
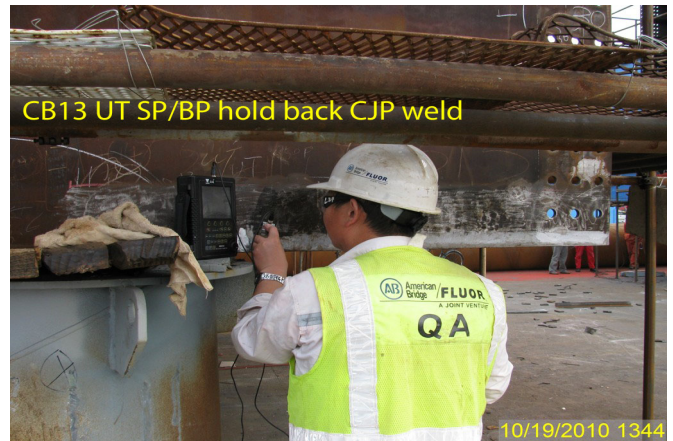
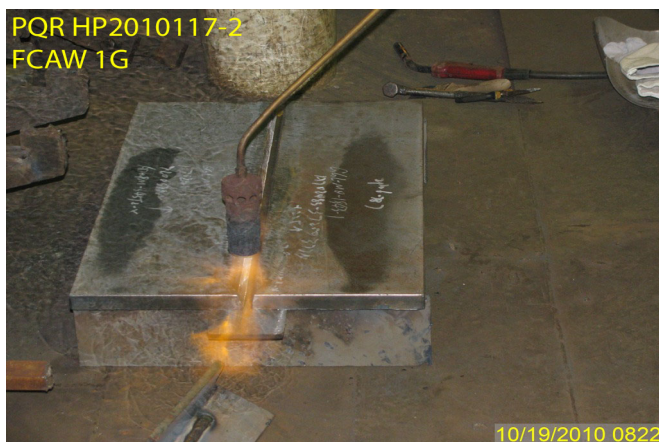
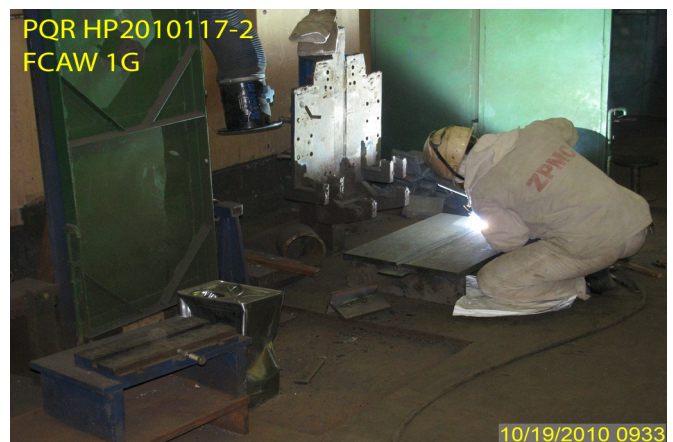
This QA Inspector observed Shielded Metal Arc Welding (SMAW) in progress of a fillet weld joint. The Weld joint is designated as OBE10A-008, 009, Arc Plate. The welder is identified as #050289 and was observed welding in the 4F (overhead) position using approved Welding Procedure Specification WPS-B-P-2114-FCM-1.

This QA Inspector observed Shielded Metal Arc Welding (SMAW) in progress of a Complete Joint Penetration (CJP) weld joint. The Weld joint is designated as OBE10A-010, Arc Plate. The welder is identified as #050289 and was observed welding in the 4G (overhead) position using approved Welding Procedure Specification WPS-B-P-2214-TC-U4b-FCM-1.

This QA Inspector observed Shielded Metal Arc Welding (SMAW) in progress of a Complete Joint Penetration (CJP) weld joint. The Weld joint is designated as OBE11B-003, Bottom Plate transverse splice. The welder is identified as #044515 and was observed welding in the 4G (overhead) position using approved Welding Procedure Specification WPS-345-SMAW-4G (4F)-FCM-repair-1 for WR16067, UT repair.

This QA Inspector observed ABF personnel performing Magnetic Particle Testing on the FL3 bottom panel I-rib stiffener hold back fillet welds at panel points 87-88.

This QA Inspector observed ABF personnel performing Ultrasonic Testing on the Side Panel to Bottom panel hold back CJP weld at panel point 86, north and south end.
